VEHICLE

Skidsteer

Highly mobile machine with significantly obscured rear vision

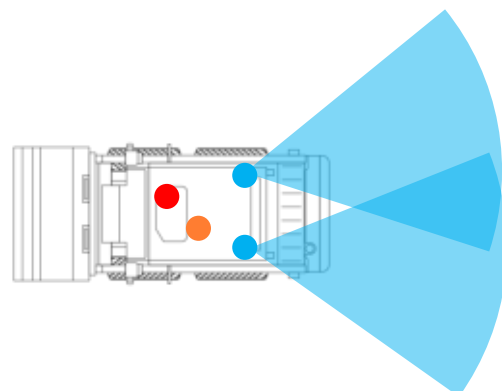
Recommended installation
NOT TO SCALE

Blindsight was fitted to the machine with both sensors observing this rear danger zones. The in-cab alert was installed in the operator’s peripheral vision.

BPU | Sensor | In-cab alert

1x Blindsight Processing Unit (BPU), 2x sensor with magnet mount, 2x 5m cable, 1x In-cab alert.

People detection on. Region of interest to mask out any visible sections of plant and limit detection distance. Alerts enabled when vehicle is in reverse.
