# Earthworks Monitoring – Kent, Sussex & Wessex

CLIENT: NETWORK RAIL

## How large-scale deployment of InfraGuard™ intelligent wireless monitoring provides early warning of slope failures

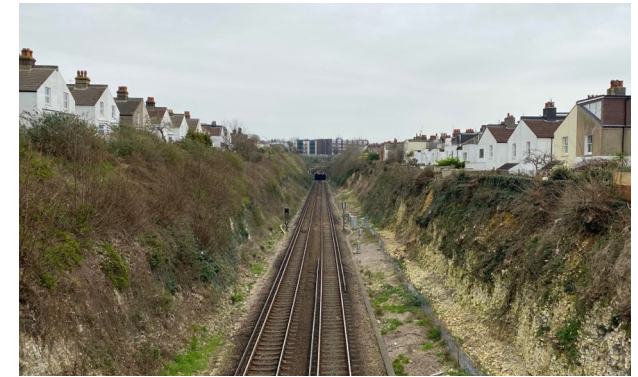
Picture 1: Typical cutting in southeast England

A number of the routes to the south and west of London in Kent, Sussex and Wessex are especially vulnerable to such events because many cutting faces are steep, close to the track and comprise layers of permeable chalk over impermeable clay.

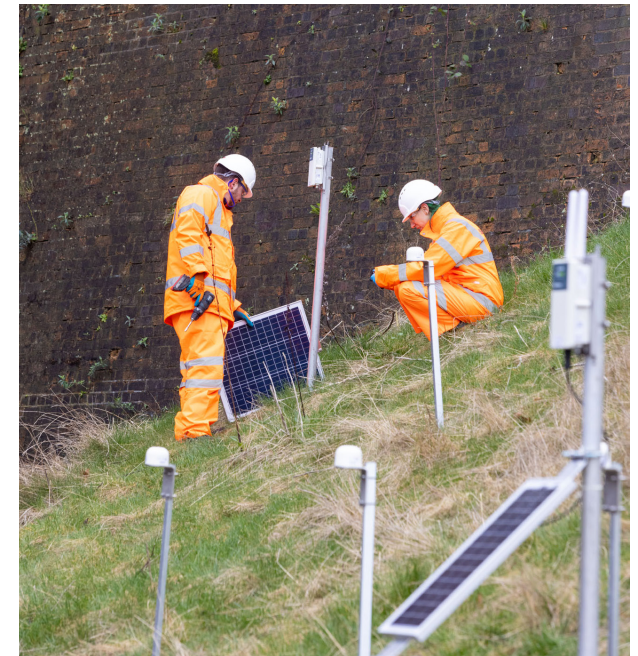
Picture 2: A typical InfraGuard™ deployment comprises rows of tilt sensing nodes fixed to metal stakes, together with a 4G Gateway, and a 4G camera

A typical InfraGuard™ deployment comprises offset rows of tilt sensing nodes fixed to metal stakes, together with a 4G communication Gateway and a 4G camera capable of operating in virtually all light conditions.

In order to make the deployment efficient and simple enough to be performed by non-specialists, a standardised approach was taken. Each site was divided into blocks of 100 m. Within each block, 50 tilt sensor nodes, two cameras and one solar-powered cellular communications Gateway were installed.

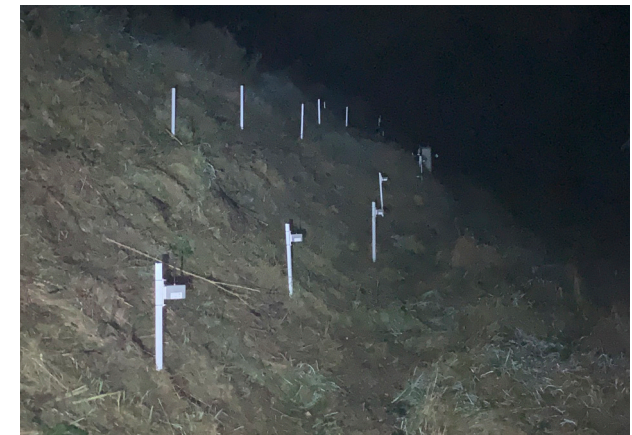
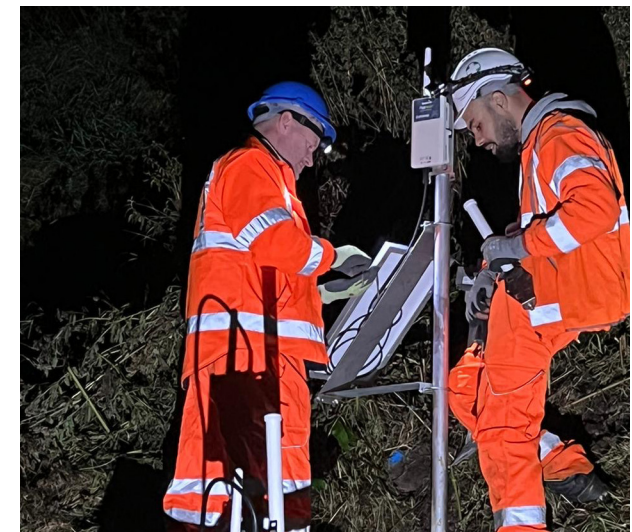
Picture 3 & 4: Installing InfraGuard in Wessex during a night-time shift

Installation on this scale brought significant efficiency gains. Towards the end of the project, an entire 100 m installation could be completed in a five-hour shift. This included ecological, topographic and buried utility surveys, selective vegetation clearance, installing nodes, cameras and the Gateway with its solar panel, and completing an as-built survey. The monitoring installation was done by contractors with no prior experience. Much of the work was done without line closures.

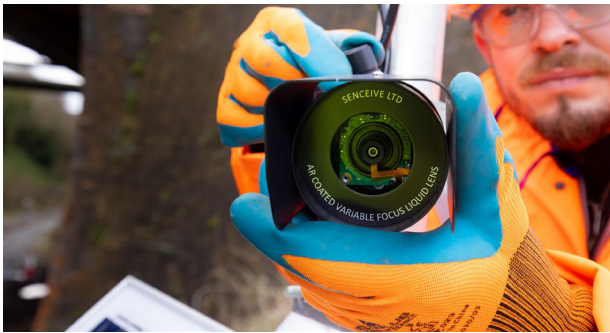
Picture 5: The 4G camera takes clear, high quality photos day or night

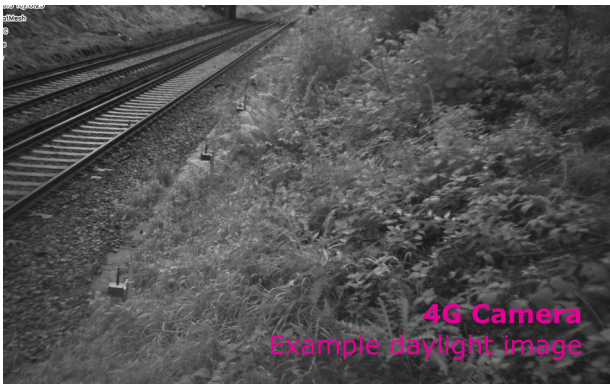
4G Camera  
Example daylight image

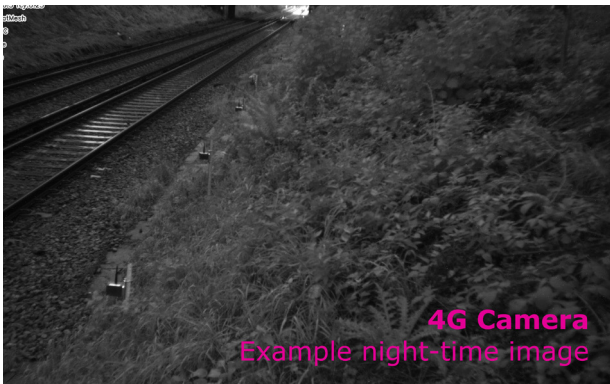
4G Camera  
Example night-time image

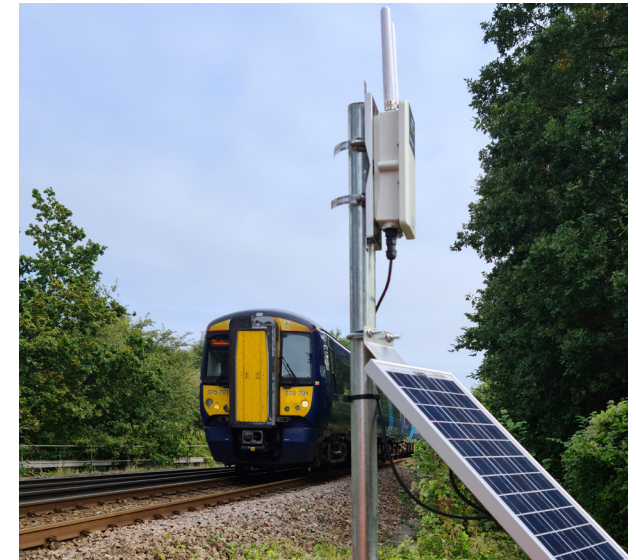
The insight provided by the InfraGuard™ system enables early identification of small movement and near real-time detection of sudden movement. It has proved effective at tracking the development of slope failures such as landslide.
